# Manhole Inspection Summary

Manhole # S37E\_\_030MH

Insp Date: **11/18/08 10:43 AM**

**Location** Address: **side 500 e lexington st**

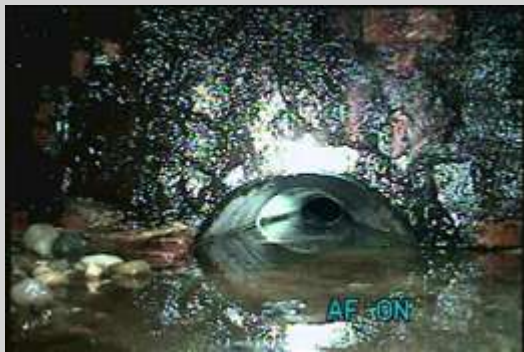
12 O'Clock Outflow

15 in. Circular Gravity Sewer  
Pipe Out @ 12 O'Clock

Invert Depth: **13.00** (ft.) Flow Characteristics: **Slow**

Deposits: ☒ None ☐ Mud ☐ Sludge ☐ Debris ☐ Grease

Infiltration: **None** Pipe Seal Cond: **Unknown**

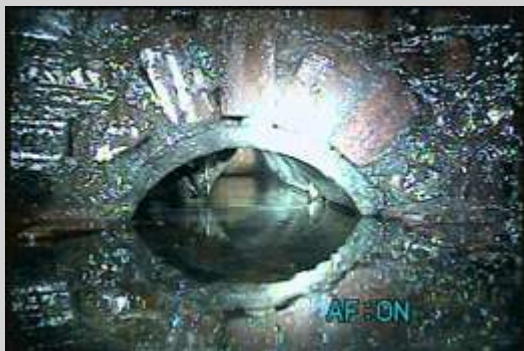
6 O'Clock Inflow

15 in. Circular Gravity Sewer  
Pipe In @ 6 O'Clock

Infiltration: **None** Pipe Seal Cond: **Unknown**
